Client Details	39 Youth Club Church Path Glamis Street Bognor Regis West Sussex PO21 1DB	Property Details	39 Youth Club Church Path Glamis Street Bognor Regis West Sussex PO21 1DB
Survey Date	28/07/2022	Weather Conditions	Dry and sunny.
Parties Present	Members from the Youth Club and the agent from West Sussex Council was present to open up during inspection.	Orientation	For the purpose of description within this report, all directions are given as facing the front elevation of the property.

Property Condition Report

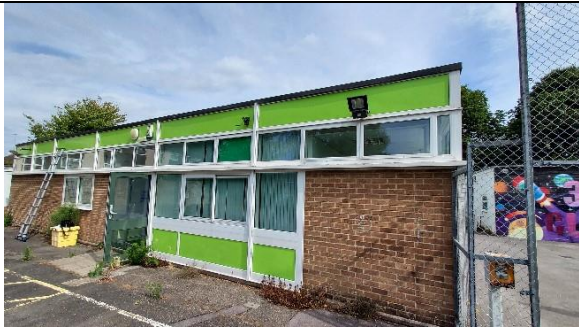
Front Elevation.

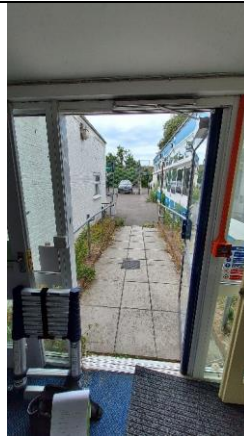
Entrance to second building.

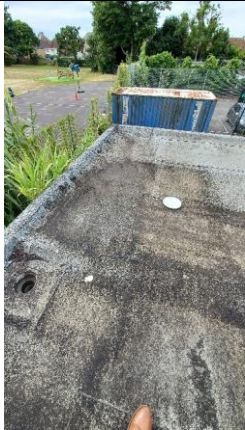
Roof view.

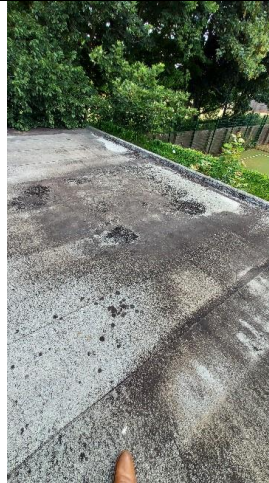
Felt to roof.

ELEMENTAL CONDITION	Description	Rating	Cost
A	Externals	Some minor brickwork repairs.	1	0
B	Roof Covering	Felt roof during the next 25 years will need replacing.	2	0
		The larger roof is serviceable condition.		
		The smaller roof the felt is in poor condition and may have a maximum of a 5-10 year life span.		
C	Soffits, Fascia's and Rainwater Goods	In serviceable condition.	1	0
		Some wire cages to stop gulleys being blocked up on the roof.		
D	Roof Structure	Reasonable condition.	1	0
E	Chimney Breasts	None.	0	0
F	External Walls	Framed building in reasonable order.	1	0
		Some minor detailing to brickwork and general maintenance.

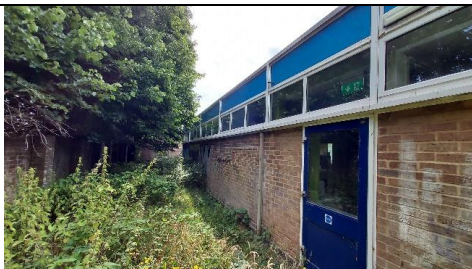
External view.

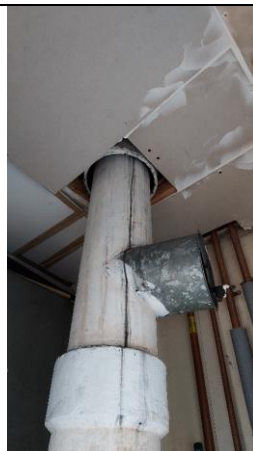
Asbestos.

ELEMENTAL CONDITION		Description	Rating	Cost
T	Paths, Hardstanding & Boundaries		Repairs required due partly to ground settlement and cracking.	2	0
			Entrance ramp reasonable condition.		
			Boundaries generally needs tidying up.		
U	Drainage (Surface & Foul)		Drains and foul could not be tested.	2	0
			Soil pipe maybe cast iron and asbestos, may have some lead content in the paint so caution is required. Fair condition as it is.		
V	Services		Gas/Electric/Water/heating/drainage and foul; tests and inspections required.	3	0
			Asbestos pipes were observed and these should be removed.		
	Sub Total			To be costed.

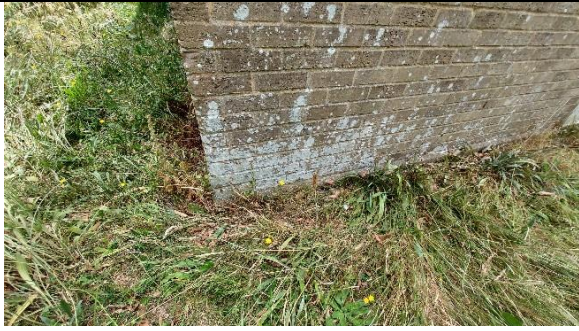
Various minor repairs of brick work.

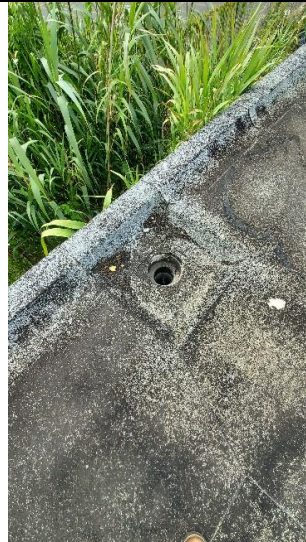
Protection covers required.

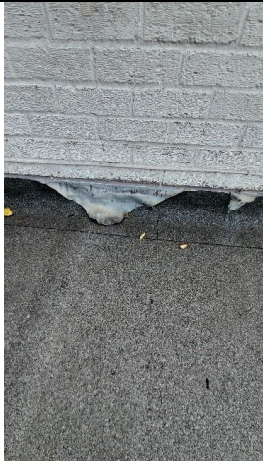
Leadwork missing.

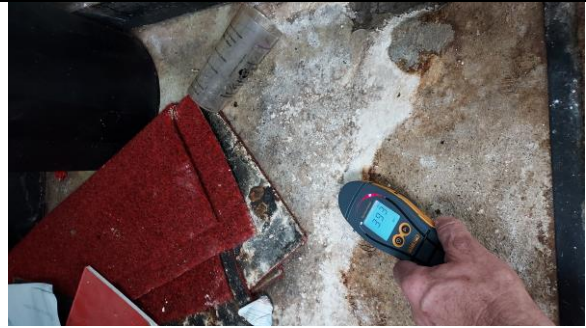
High moisture reading to some floors.
